# DRAGUN CORPORATION

January 2, 2007

SUBJECT: Former Plant 5, Delphi Flint West  
Project #22117-14

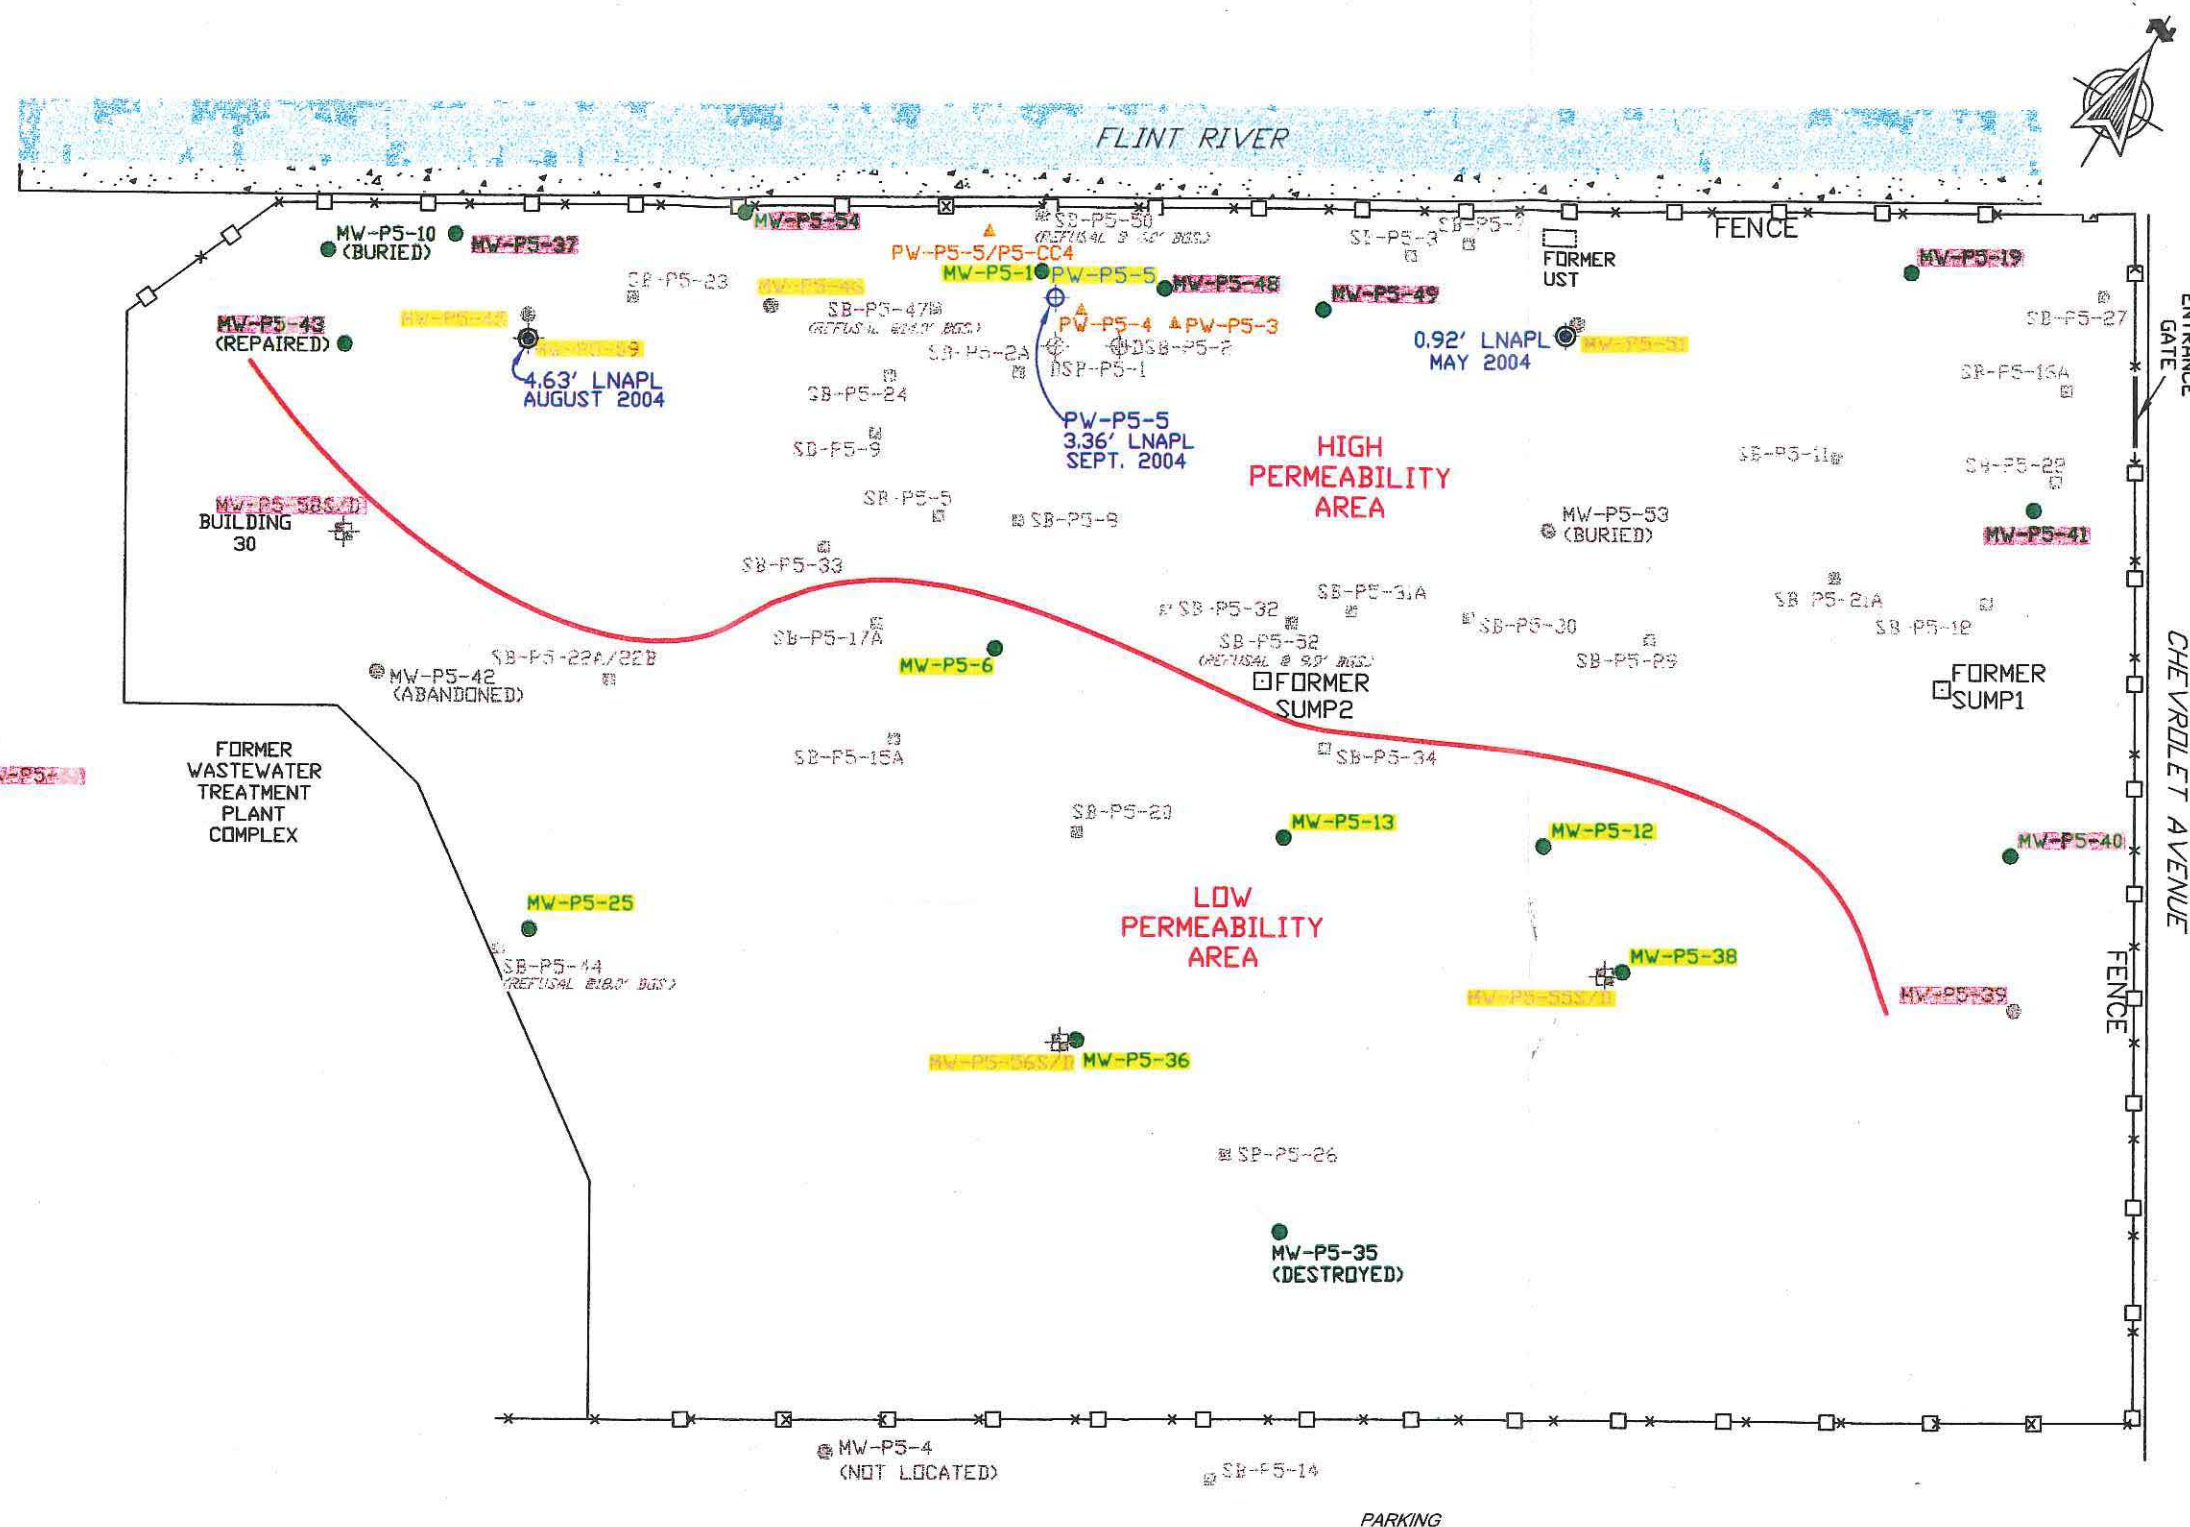
FIGURE 2  
DISTRIBUTION OF LNAPL, MAY 3, 2004  
FORMER DELPHI FLINT WEST, PLANT 5  
FLINT, MICHIGAN

Groundwater elevations were last determined on May 3, 2004. The High Permeability Area is unconfined and represents the water table while the Low Permeability Area is confined (Figure 2). The equipotential map indicates two main flow directions. First, the majority of the groundwater flow is essentially northward toward the river. Second, there is a groundwater low centered near MW-P5-1 (see Figure 2 for the location of this well). Although there are no data that specifically show this, The Dragun Corporation suspects this potentiometric low is due to groundwater leakage into the sanitary sewer or the material around the sanitary sewer, as it runs below the Flint River.

Areas of Interest: The Site consists of two permeability zones (see red line in Figure 2) that have distinctly different LNAPL distributions. The "Low Permeability Area" occupies the southern and northwest part of the Site. The natural soil beneath the Low Permeability Area is clayey moraine soil. The LNAPL that accumulates in the monitoring wells in this area is viscous and "clean-looking;" however, the thickness of LNAPL observed in monitoring wells in this area is inconsistent with the negligible amounts of LNAPL that were observed in the soil during drilling. The Dragun Corporation speculates that small amounts of LNAPL move into the wells through the well screen from the soil in this area and gradually displace the standing water in the monitoring well. Since the groundwater in this area is confined, the static water levels in the monitoring wells are far above the top of the well screens. Therefore, although there are several feet of oil in the monitoring wells in the Low Permeability Area, this does not represent the height of LNAPL in the soil. The LNAPL in the monitoring wells in the Low Permeability Area is the result of small amounts of oil that enter at the screen and float to the top of the standing water in the well that reflects the original groundwater head.

The "High Permeability Area" occupies the northern and eastern portions of the Site and coincides with the flat areas of the Site (Figure 2). In the High Permeability Zone near the Flint River, the clayey morainic soils were not encountered by soil borings that extended 20 feet below ground level. The natural and fill soils in this area are sandy to gravelly. The LNAPL in the High Permeability Area looks dirty and is much less viscous than that in the Low Permeability Zone. Furthermore, the thickness of LNAPL observed in the monitoring wells in this area is consistent with the thickness observed in the soil during drilling.

Figure 2 shows the distribution of LNAPL observed in monitoring wells on May 3, 2004. Figure 2 indicates that (1) LNAPL has been delineated to the east and west, (2) LNAPL is not present on the groundwater in all areas along the Flint River, (3) the absence of LNAPL along the Flint River in the northwest corner of the Site is consistent with the groundwater flow direction in the northwest, which is away from the river and appears to be influenced locally by the sanitary sewer, (4) LNAPL thicknesses in the High Permeability Area ranges from about one to five feet, and (5) no LNAPL thicknesses are provided for the Low Permeability Area monitoring wells because the thicknesses in the monitoring wells do not reflect that observed in the soils.

Since the Site geology, hydrogeology, and LNAPL distribution are well understood, no further remedial investigation is required at the Site. The remedial action at the Site will involve belt skimmers in the High Permeability Area. A belt skimmer has been acquired for the Site and will be used for LNAPL recovery beginning in early 2007. Additional belt skimmers will be installed as required. In addition, LNAPL will be removed from the Low Permeability Area by manual bailing as required.
